Inspect steam reformers and catalyst tubes with infrared thermography

Infrared thermography is a useful inspection tool to help locate problems in steam reformers while the units are online and fired. There are three main areas in a reformer that can be efficiently inspected with thermography. While there are common and codified inspection and diagnostic practices used in the industry today, some of these practices are unknowingly wrong and may have a large impact on the data collected over the years.

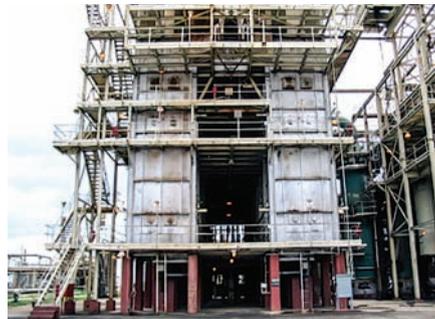
FIG. 1. A horseshoe-type design with one row of tubes per firebox/cell.

Steam reforming takes place in a steam reformer furnace. The furnace is usually a large refractory-lined box with gas burners, heating many catalyst-filled tubes that carry the feed (natural gas) and steam. Depending on the design, the reformer's firebox or cell may contain only a single row of tubes (FIGS. 1 and 2) or it may contain multiple rows (FIGS. 3 and 4), making it more difficult to obtain accurate temperature data.

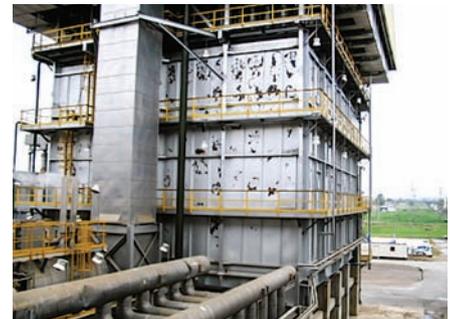
FIG. 3. Single firebox-type design with multiple rows of tubes in one firebox/cell.

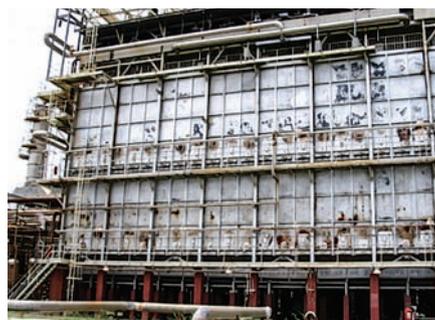
FIG. 2. Side view of a horseshoe design reformer.

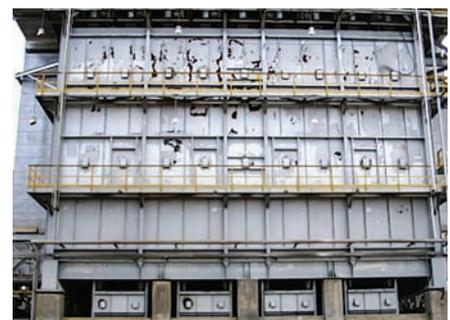
FIG. 4. Side view of single firebox/cell design reformer.

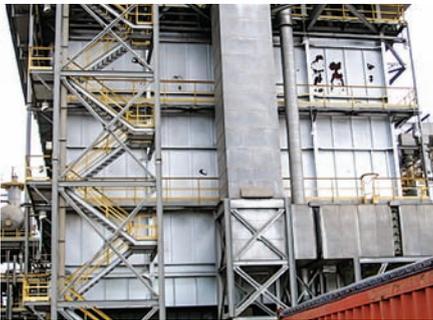
FIG. 5. Low-emissivity silver paint common on reformers.

Refractory furnaces are usually painted with a metallic silver paint (FIG. 5). Emissivity is an important issue when it comes to temperature accuracy. While many inexperienced thermographers and inspectors take emissivity for granted, temperature accuracy is an important aspect of reformer refractory inspection, as it assists design and plant engineers in trouble-

The low emissivity of the paint not only poses a temperature measurement problem, but it also poses a relevant indication determination challenge. Surrounding a reformer is a melee of hot flanges, piping, and vessels that can easily be reflected off the surface of the paint, resulting in false indications. Plant inspectors using spot radiometers often misinterpret reflection problems as true indications. Also, changes in paint surface conditions due to scrapes, scuffs and charring can result in emissivity changes and can show a $\Delta T > 40^{\circ}\text{C}$, easily confusing an inexperienced thermographer and leading to data misinterpretation.

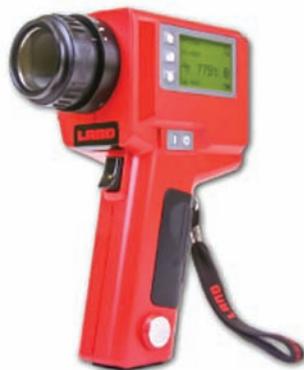
FIG. 9. Single-point (spot) infrared pyrometer.

Single-point infrared pyrometers. Almost every petrochemical plant uses a portable, handheld spot infrared pyrometer to trend and monitor tube temperatures (FIG. 9). The main reason plant engineers and operators use these devices is because they are relatively inexpensive and easy to use. They are also very accurate and stable; they are almost never used properly by plant engineers and operators. Users have the notion that all they have to do is aim, pull the trigger and get a temperature. Many fail to understand that these instruments are infrared thermometers and are susceptible to the same errors as thermal imagers and other infrared thermometers.

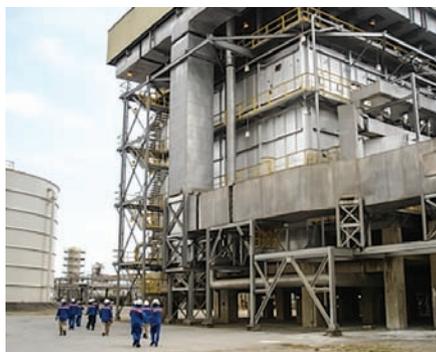
FIG. 10. Plant operators and inspectors approach a reformer for hands-on single-point infrared pyrometer training.

Application and equipment training programs specifically geared to the plant operator and engineer on the proper use of spot-infrared pyrometers are important (FIG. 10). From observing a wide array of training programs across a variety of companies, it has been determined that temperature consistency within 1°C to 6°C has been achieved from operator to operator, where previously it was an average of 20+°C (FIG. 11).

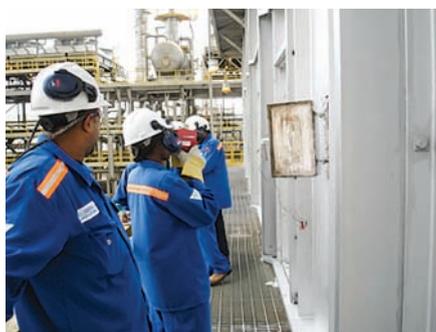
FIG. 11. Plant operators and inspectors applying the knowledge learned during training.
